Assessment Report for
Ohio, SPS Experiment 1

Visit date: November 12, 2003

SITE ID: 390100
LOCATION: US 23 SB (Mile Post: 19.7) near Delaware
VISIT DATE: November 12, 2003
VISIT TYPE: Assessment

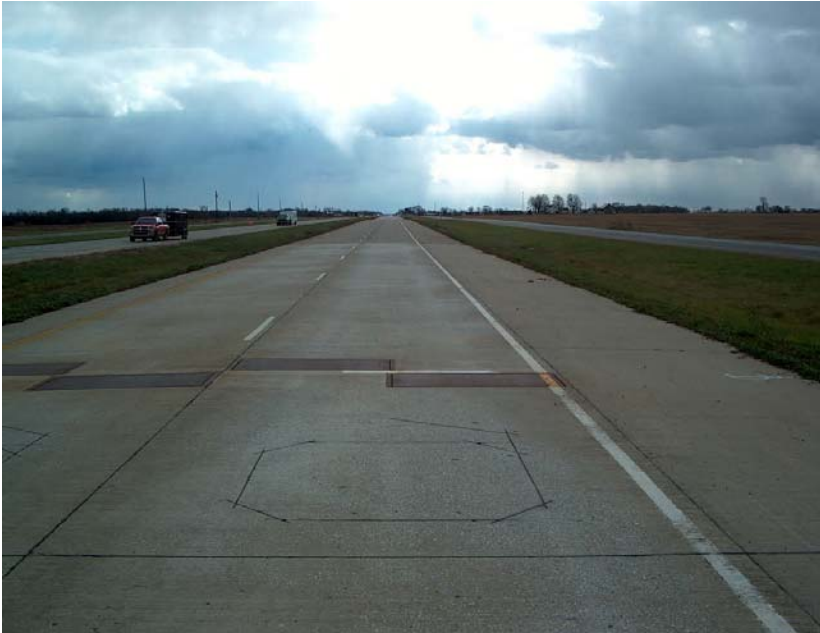
Figure 13-1 Pavement Condition of 390100 site

The pavement appears to be in a good condition except for the faulting at the transition of asphalt concrete pavement to cement concrete pavement 165 feet prior to the sensors. The LTPP WIM index thresholds for both SRI and LRI for the wheel path and runs to the right and left of it all exceed the threshold currently used to determine the impact of smoothness on equipment performance.

The pavement appears to be in a good condition except for the faulting at the transition of asphalt concrete pavement to cement concrete pavement 165 feet prior to the sensors. Figure 13-1 shows the overall condition of the pavement. Figure 13-2 shows the transition from asphalt concrete to cement concrete.

The consistent values of the smoothness index across all passes indicate that pavement remediation by grinding or complete replacement may be necessary. The pavement currently has transverse grooves throughout the section except immediately adjacent to the section. Their precise impact is unknown. If this is the typical practice for the state, and a pavement without grooves is not an option, doing an evaluation as a benchmark only rather than an annual activity should be considered.

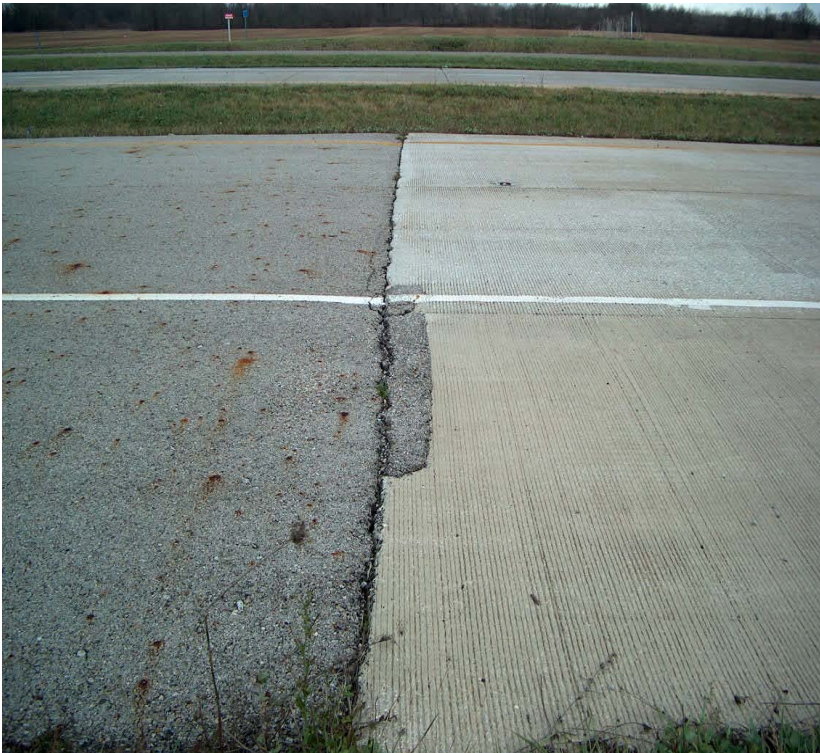
Figure 13-2 Asphalt concrete to cement concrete pavement transition at 390100 site

Distress data supports the recommendation that pavement replacement is required at the asphalt/PCC transition point located 165 feet prior to the WIM scale area due to a moderate fault at the point of transition as shown in Figure 13-2. The actual truck/pavement interaction as a result of this fault could not be viewed on site or videotaped due to the rerouting of southbound traffic.

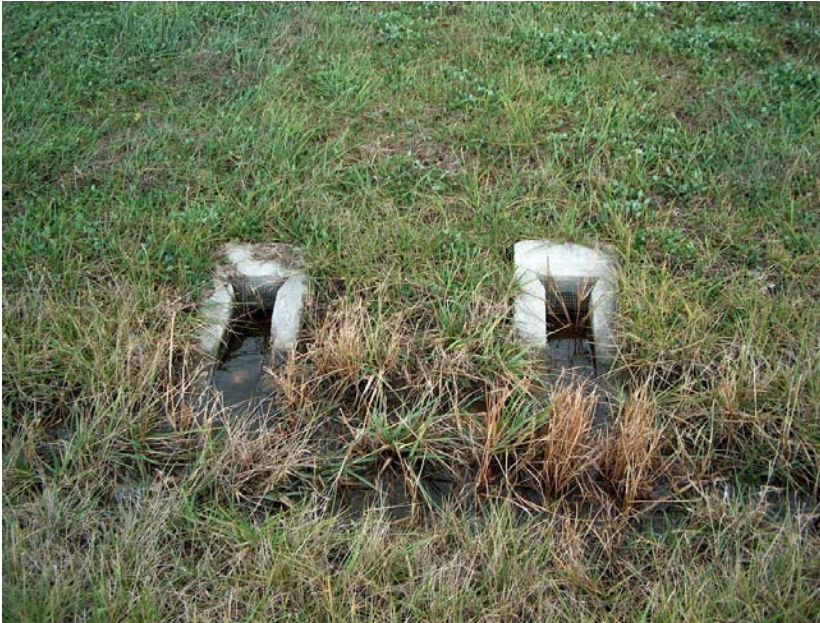
Figure 15-1 Drainage Culvert at site 390100

A visual inspection discovered that the drainage area for the load cells is inadequate and needs to be improved. Figure 15-1 shows the drainage culvert at the site. The culvert needs to be dug deeper or made larger to permit the proper permeation of water being drained from the load cell sensor.

A visual inspection discovered that the drainage area for the load cells is inadequate and needs to be improved. This is cause for concern because the water can back up to the

load cell pits and freeze, preventing the load cell mechanism from moving freely, reducing the weighing capability of the sensor. The culvert needs to be dug deeper or made larger to permit the proper permeation of water being drained from the load cell sensor.
